CASE STUDY: Vegetable Processing Facility
LOCATION: Connell, WA USA
PROJECT: CAF Wastewater System Upgrade
GOAL: Reduce TSS and Lagoon Solids
WORD KEYS: CAF, TSS, Lagoon, Sustainability

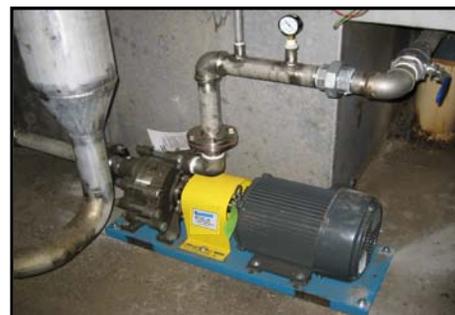
The CAF system had an inefficient gas dissolving system. The aeration method was a centrifugal design producing mostly non-functional large bubbles. This system had un-timely break downs over the course of years. Repairs were expensive. Significantly these break-downs launched heavy solids into the lagoon system for extended periods as the plant continued to operate. RPC determined that by replacing the existing aeration system with a new AISI 316 stainless steel **MAX RGT™** regenerative turbine pump, an upgraded CAF was possible. The new system entailed the pump, control valves, gauges and piping. All were to be positioned conveniently adjacent to the CAF effluent chamber. The design recycled effluent water through the pump and would achieve complete air saturation it in a single pass.

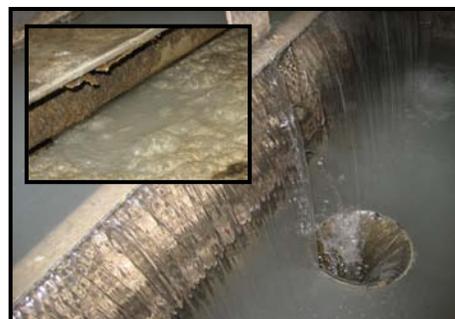
RPC had the new pump delivered quickly. The maintenance crew had the **MAX RGT™** pump installed with quality stainless piping and control components. Upon start-up the upgraded CAF produced much improved TSS results. The **MAX RGT™** pump produced very fine 20-30 micron bubbles. These micro bubbles captured the large portion of insoluble solids and effectively floated them to the surface. Plant personnel found they had a drier, more consistent sludge blanket. They also found the system needed less chemistry to achieve results.
